SEALING SENSE

Q. *What are the principal symptoms, causes and corrective actions for failure of mechanical seals induced by mechanical breakdown?*

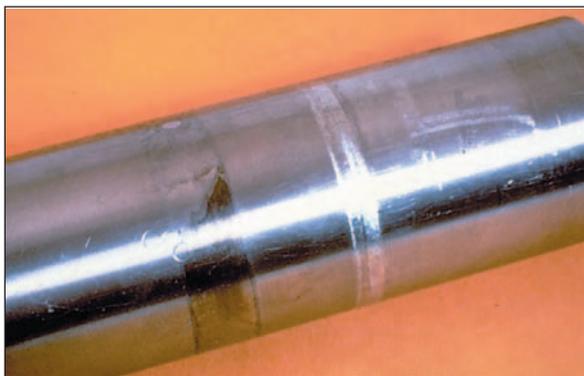
A. *Fretting* is one of the most common types of mechanical attack. Induced mechanically, it ultimately leads to corrosion. Fretting causes leakage past secondary seals and leaves the shaft or sleeve beneath the secondary seal corroded and damaged. This area will appear pitted or bright and shiny compared with the overall finish of the shaft or sleeve.

Figure 1. Results of fretting that led to a corroded and damaged shaft beneath secondary seal

Fretting results from reciprocating movement of secondary seals over a shaft sleeve, with consequent removal of the passive coatings intended to protect the sleeve from corrosion. Constant vibration of the shaft packing over this surface also removes the passive coating and allows further corrosion to occur.

Corrective actions include: (1) ensuring that shaft run-out, deflection and axial end-play are held to maximum of 0.003" (0.076 mm) total indicated run-out; (2) using hard-facing alloys, chrome oxide or aluminum oxide protective coatings under the area where secondary seals slide; (3) upgrading shaft or sleeve base material to one that doesn't depend on passive coatings for corrosion resistance (example: titanium); (4) changing PTFE V-rings, wedge rings and taper rings to elastomer O-ring secondary seals; (5) switching to non-pusher seals, such as rubber-PTFE or metal-bellows seals with truly static secondary seals.

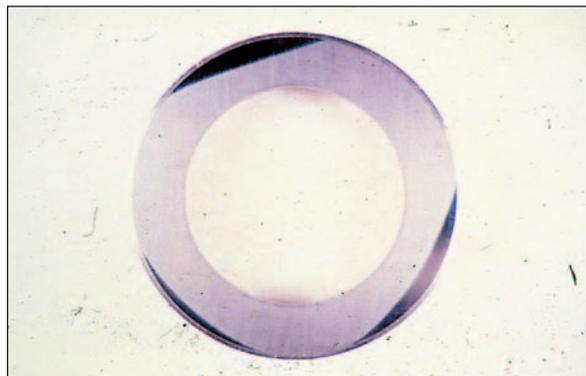
Symptoms of *face distortion* include excessive leakage at the seal. Visual examination of the seal faces shows a nonuniform wear pattern, which is sometimes difficult to detect. By lightly polishing the seal faces on a lapping plate, high spots will appear at two or more points. This indicates uneven wear. Several things lead to seal face distortion:

1. Improper assembly of seal parts, causing non-uniform loads at two or more points around the seal face—this often occurs with rigidly mounted or clamp-style seal faces, when uneven torquing of gland nuts transmits uneven deflections directly to the seal faces.
2. Improper cooling, inducing thermal stresses and distortions at seal faces.
3. Improper processing of seal parts, producing a saddle surface or high spots at several points around the seal faces.
4. Improper gland supports, from debris or deposits left in the gland, and/or physical damage, upsetting metal in the gland and transmitting an uneven load to the stationary seal face.
5. Poor surface finish at the face of the stuffing box, due to corrosion or mechanical damage.

Figure 2. Evidence of uneven wear on mechanical seal due to face distortion

Corrective actions include: (1) relapping seal faces to remove cause of distortion; (2) using flexibly mounted stationary-seal faces to compensate for gland distortion; (3) readjusting glands by positioning gland nuts finger-tight, then torquing them evenly to the specified value.
