S E A L I N G S E N S E

Q. What are the symptoms, causes, and corrective actions for failure of mechanical seals by thermal attack?

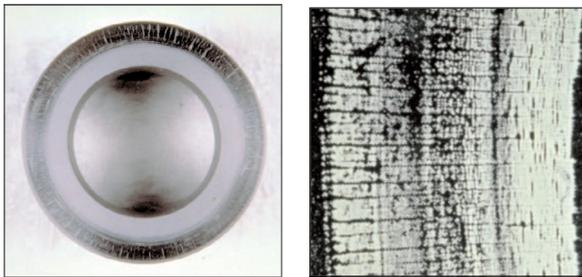
A. One symptom of thermal attack is the appearance of fine-to-large radial cracks that emanate from the center of the metal or ceramic ring. Characterized as *heat checking*, these cracks act as cutting edges on the carbon-graphite and other seal face materials, and the consequent scraping action rapidly wears out the seal.

Common causes of heat checking include: (1) insufficient lubrication; (2) vaporization at the seal faces; (3) inadequate cooling; and (4) excessive pressures and velocities. Any one or a combination of these factors can result in higher friction and heat at the seal faces. The excessive thermal stresses that develop will result in fine fractures.

Figure 1. Ceramic ring with typical heat checking cracks

Corrective Actions include:

- Checking operating conditions to ensure they are within the prescribed limits for the seal.
- Confirming adequate coolant flow at the seal faces to carry away seal-generated heat; guidelines are that (a) the temperature rise of the fluid flowing through the seal cavity should not exceed 40° F (22° C); and (b) pressure of the seal cavity product should be maintained 25 PSI (1.72 bar) above the vapor pressure of the seal cavity fluid to avoid vaporization.
- Checking that the seal is not overloaded so that a thrust bearing or thrust collar in the equipment becomes damaged or inoperative, thereby creating excessive seal face loads.
- Upgrading to seal face materials with higher pressure-velocity (P-V) limits and resistance to heat checking such as tungsten carbide or silicon carbide. (P-V is the pressure (PSI) at the

seal faces, multiplied by the velocity (ft/min) of the outside diameter of the seal face.)

- Consulting the manufacturer to obtain revised dimensions that will reduce the hydraulic load at the seal faces to provide a lower P-V for the same face materials.
- Verifying ample cooling and lubrication at the seal faces.

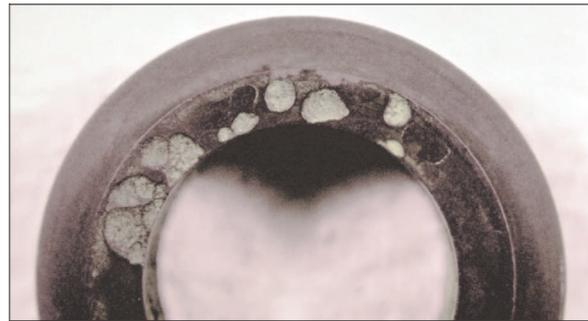
Spalling is similar to blistering, but occurs on surfaces away from the seal face, such as the outside diameter and the back of the seal. Like blistering, spalling is caused by excessive thermal stresses in a carbon-graphite seal. Unlike blistering, however, spalling seems to occur with virtually any fluid, and is the result of moisture suddenly being driven off when the seal is overheated. It is almost always due to dry running of the seal. If seal parts are heavily spalled, it's a good indication that the equipment

Figure 2. Carbon-graphite seal exhibiting spalling

was allowed to run dry for an extended period of time.

To avoid dry running of a mechanical seal, a pressure or load switch should be added to the equipment. Or, an alternative sealing method should be supplied, such as a double seal incorporating a thermal-convection or forced-lubrication system.
