SEALING SENSE

How to troubleshoot expansion joint failures

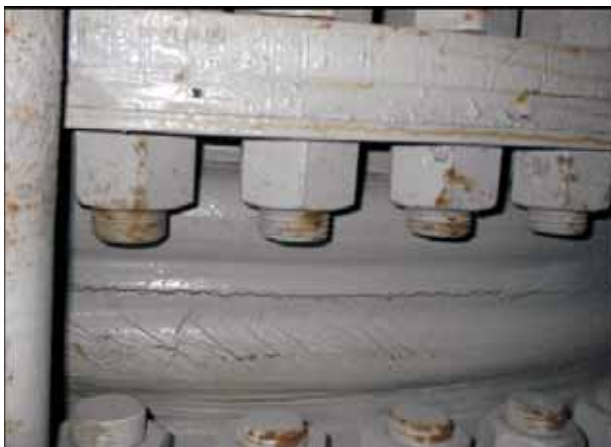
Exterior surface cracking is most commonly the result of aging and/or elevated temperature. As rubber ages, it becomes hard and brittle and loses inherent flexibility and resilience. Cracking or crazing may not be serious if only the outer cover is involved and the fabric is not exposed. If necessary, repair onsite with rubber cement where cracks are minor. Carefully inspect cracks to determine if underlying fabric reinforcing plies are compromised.

Figure 1. Typical Expansion Joint Surface Cracking

Cracking where the fabric is exposed and torn, indicates the expansion joint should be replaced. Such cracking is usually the result of excess extension, angular or lateral movements. Such cracking is identified by (1) a flattening of the arch, (2) cracks at the base of the arch and/or (3) cracks at the base of the flange. Cracking at the base of the flange/arch is more associated with movement and misalignment.

Note: As a corrective action, measure the face-to-face and lateral alignment prior to ordering a replacement and install control units to maintain acceptable movement limits of the expansion joint during operation.

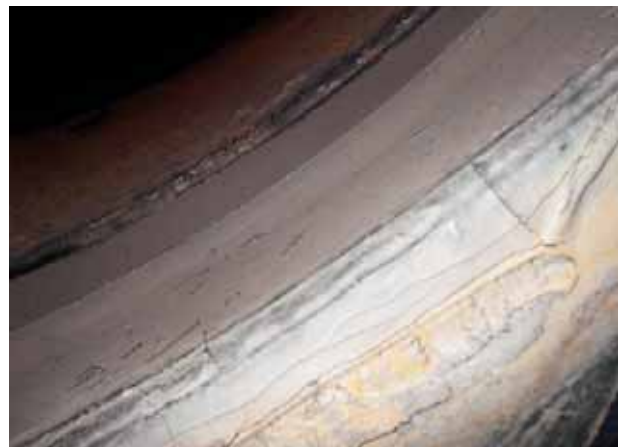
Some blisters or deformations—when on the external portions of an expansion joint—may not adversely affect the performance of the expansion joint. These blisters or deformations are cosmetic in nature and do not require repair.

If major blisters, deformations and/or ply separations or delamination exist in the tube, the expansion joint should be replaced as soon as possible. The root cause of delamination is either over-torqued bolts, chemical attack by the media, aged rubber or some other form of break in the inner tube layer. Corrective actions include replacing the aged product and ensuring the correct material selection for the application.

Figure 2. Expansion Joint Surface Delamination

Ply separation at the flange outer diameter (O.D.) can sometimes be observed and is not a cause for replacement of the expansion joint.

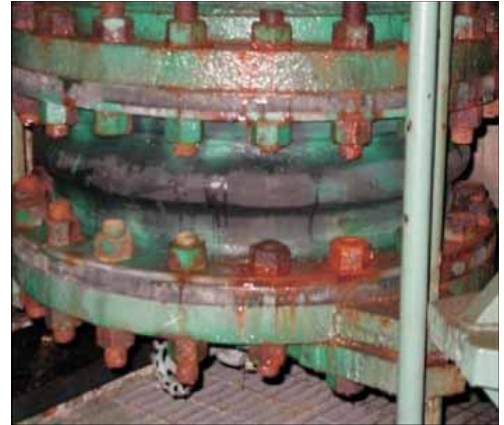
It is most important to determine where the leak originated prior to implementing any corrective action. If leakage or weeping is occurring from any surface of the expansion joint, except where flanges meet, replace the joint immediately. If leakage occurs between the mating flange and expansion joint flange,

Figure 3.
Leaking
Expansion
Joint

tighten all bolts. (Make sure that a gasket has NOT been installed between the joint's flange face and the mating flange.)

If this is not successful, turn off the system pressure, loosen all flange bolts and then retighten bolts in stages by alternating around the flange. Make sure there are washers under the bolt heads, particularly at the split in the retaining rings. There should be no gap at the retaining ring split. Remove the expansion joint and inspect both rubber flanges and pipe mating flange faces for damage and surface condition. Repair or replace as required. Also, make sure the expansion joint is not over-elongated as this can tend to pull the joint flange away from the

mating flange resulting in leakage. If leakage persists, consult the manufacturer for additional recommendations.

Root Causes Include: Under-torqued bolts; irregular sealing surface (optimal mating surface is full face flat flanges); over-extension; and chemical attack by the media.

Corrective Action: Tighten the bolts to the manufacturer's torque recommendations. Change to proper design and chemically compatible material. Measure the face-to-face dimension prior to replacement.
