SEALING SENSE

Troubleshooting Bolted Flange Connection Leaks

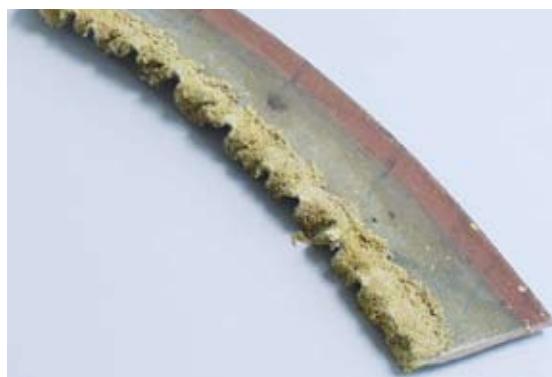
Figure 1. Non-metallic gasket showing chemical attack.

Gasket is badly corroded

Corrosion of metal gaskets is probably more easily diagnosed than that of rubber or fiber gaskets. Damage to non-metallic gaskets can be misdiagnosed since mechanical and chemical attack might look similar.

Non-metallic gaskets can be crushed, which will typically cause splitting of the gasket in arcs that are parallel to the circumference of the gasket (as opposed to radial splits). Erosion of the gasket will cause gouging at the gasket ID, but the damage will be limited to one or two areas. Edges of eroded areas will be smooth, not ragged, and the surface at the ID will be concave.

If the damage is due to chemical corrosion, select a replacement material with improved corrosion resistance.
