Improper Gasketed Joints Can Be Deadly

By **Jim Drago**, FSA Member, Garlock Sealing Technologies & **Ron Frisard**, FSA Member, A.W. Chesterton

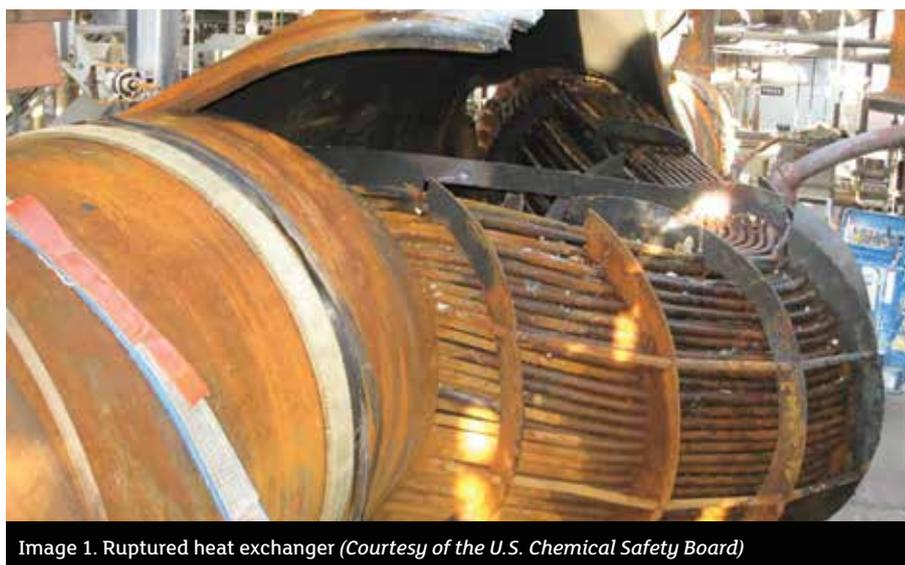
A heat exchanger, known as E-6600E, catastrophically ruptured at the Tesoro refinery in Anacortes on April 2, 2010 (see Image 1). Highly flammable hydrogen and naphtha at more than 500 F were released from the ruptured heat exchanger and ignited, causing an explosion and an intense fire that burned for more than three hours. The rupture fatally injured seven Tesoro employees (one shift supervisor and six operators) working near the heat exchanger.

Image 1. Ruptured heat exchanger (Courtesy of the U.S. Chemical Safety Board)

The 2010 explosion at Anacortes was not directly caused by poor gasket application. The NHT heat exchanger vessel ruptured and caused the fire because of the vessel material's high temperature hydrogen attack, which is metal deterioration from high temperature hydrogen contact. Because of safety complacency that accepted heat exchanger leaks during startup, additional personnel were required to manage those leaks, which led to the tragic loss of life. Technology and know-how are available to assure safe sealing that can make sure everyone safely ends the work day. ■
