# The Danger of Complacency in Equipment Selection & Installation

One wrong selection could be fatal.

By **Ron Frisard**  
A.W. Chesterton

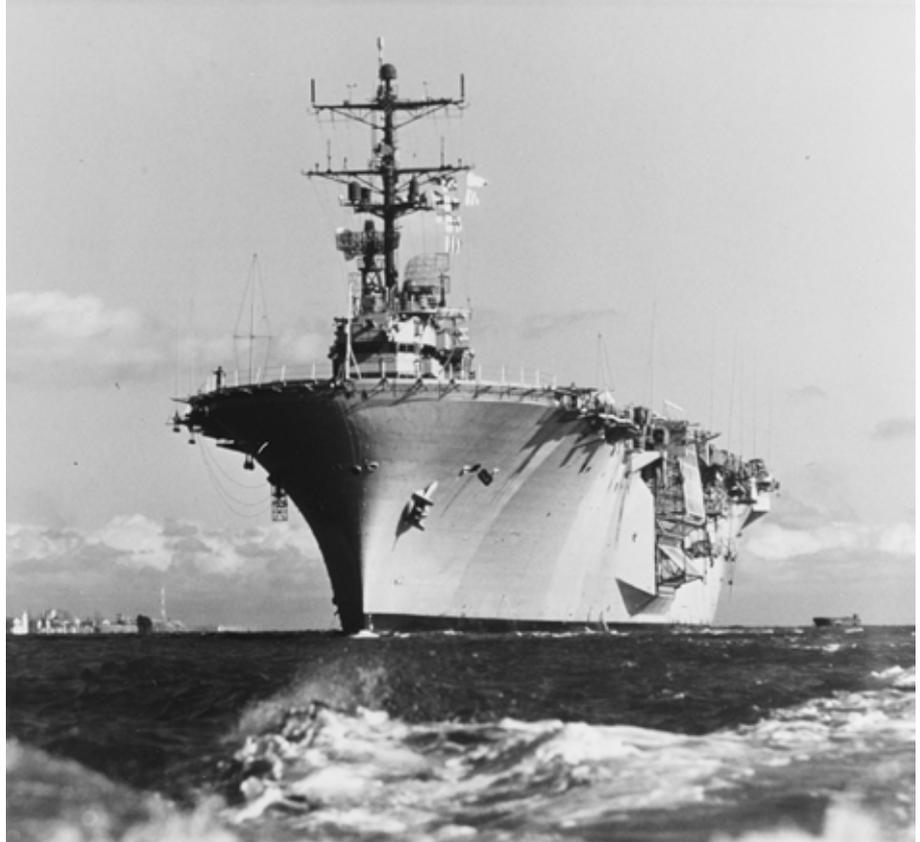
The USS Iwo Jima was an amphibious assault ship that experienced a catastrophic event in October 1990 when a valve failed, ultimately killing 10 crewmen. (Image courtesy of author)
