What is the impact of reliability on the sealing system energy footprint from pump shut down, repair and re-commissioning?

Last of Four Parts

This month's "Sealing Sense" was prepared by FSA member Henri Azibert

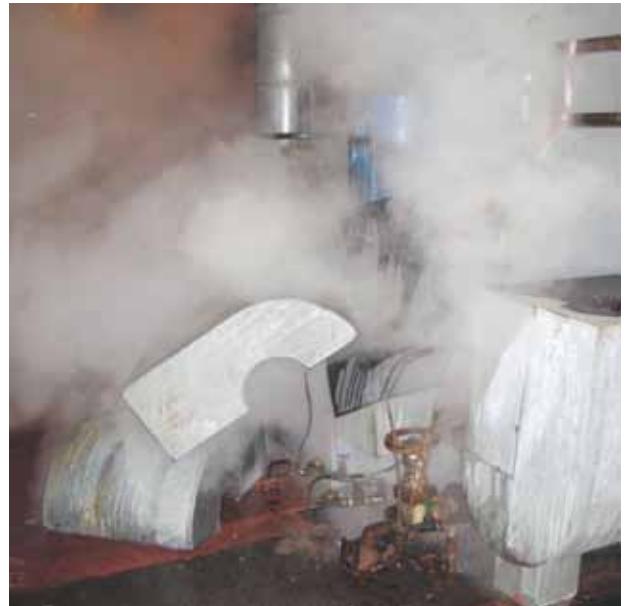
Time to fix the leak

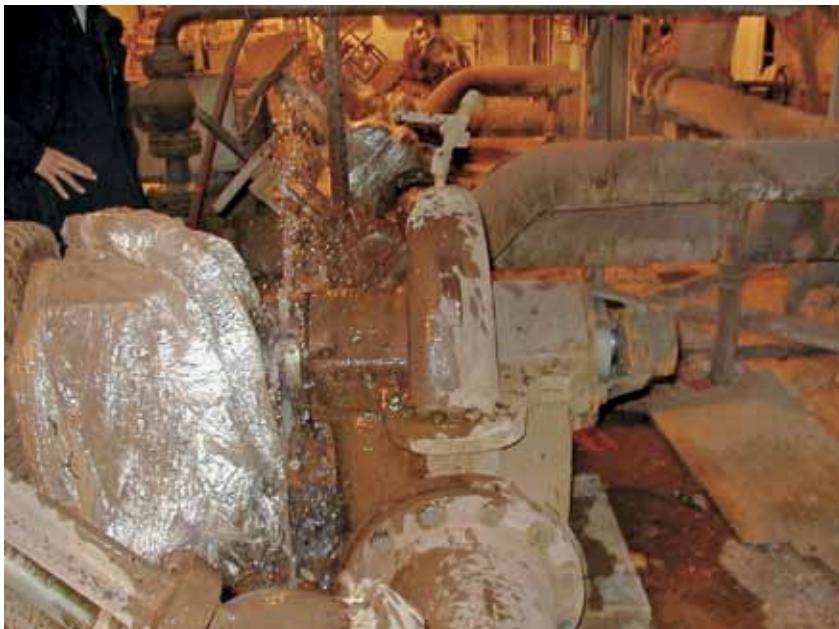
Past the time to fix the leak
